**Flood Control Project Maintenance
Levee Inspections**
LMA District Cover Sheet
Spring 2019 Levee Inspection Results

Reclamation District No. 0070 Meridian

Spring 2019 Levee Inspection Results

Waterway			Bank	Unit Miles
Unit No. 01 Sutter Bypass			Right	7.92
	Spring (March - May)	Summer (June - August)	(September - November) Fall	Winter (December - February)
Unit Maintenance Rating (Fall Only)				
Date of Inspection	4/2/2019 - 4/2/2019			
DWR Inspector	Makar Sokol			
Accompanied By	Andy Duffey			
	Mike Engelmann

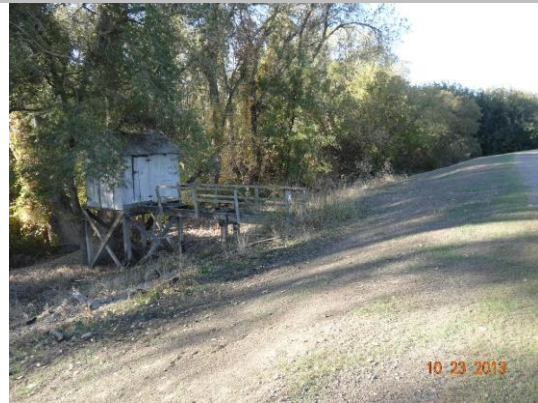
Photo 1 of 3 : UCIP_SP_2019_23966_42128.jpg

Comment Code						
Inspector Comment						
FS_ID:23966 DS_ID:21387 EP_NO: 9966 Repair Type: Non-Urgent Crossing Status: Indicator Found UCIP Comments: Pipe daylight at waterward side blocked. Unable to determine if connection is present--need to contact owner to determine if owner plans to use. If crossing is no longer in use owner will need to coordinate with DWR inspector and CVFPB to remove according to Title 23 requirements. Unable to determine if crossing is in use. This crossing is referenced in the USACE Periodic Inspection as item USACE_CESPK_MRD2_2012_p_0371. FIELD_STRUCT_DESC: 10-inch coated steel irrigation discharge pipe and 1.5-inch electrical conduit of an unknown material through the levee, 12 feet and 8 feet below the crown, respectively. Pipe is concrete encased under the crown, between the shoulders. Concrete cutoff wall under each shoulder. Pump and gate valve on a pile structure in the stream. Walkway to the pump. Concrete standpipe on the landside (LS). (retain 10-inch concrete-encased steel pipe, pump and gate valve, concrete standpipe, and two concrete headwalls authorized under Automatic Board Order (ABO) issued as Permit No. 9966, 1976 - Ray and Janice Anderson). [Additional Reference(s): DWR Levee Log, 2007. USACE Sacramento O&M Manual 134, June 1953, (Station 689+50)]. FS Date: 10/23/2013

Pump house located on waterward side.

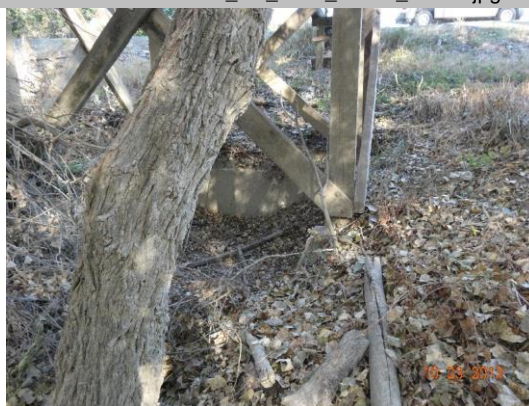
Photo 2 of 3 : UCIP_SP_2019_23966_42126.jpg

Comment Code						
Inspector Comment						
FS_ID:23966						
DS_ID:21387						
EP_NO: 9966						
Repair Type: Non-Urgent						
Crossing Status: Indicator Found						
UCIP Comments: Pipe daylight at waterward side blocked. Unable to determine if connection is present--need to contact owner to determine if owner plans to use. If crossing is no longer in use owner will need to coordinate with DWR inspector and CVFPB to remove according to Title 23 requirements. Unable to determine if crossing is in use. This crossing is referenced in the USACE Periodic Inspection as item USACE_CESPK_MRD2_2012_p_0371.						
FIELD_STRUCT_DESC: 10-inch coated steel irrigation discharge pipe and 1.5-inch electrical conduit of an unknown material through the levee, 12 feet and 8 feet below the crown, respectively. Pipe is concrete encased under the crown, between the shoulders. Concrete cutoff wall under each shoulder. Pump and gate valve on a pile structure in the stream. Walkway to the pump. Concrete standpipe on the landside (LS). (retain 10-inch concrete-encased steel pipe, pump and gate valve, concrete standpipe, and two concrete headwalls authorized under Automatic Board Order (ABO) issued as Permit No. 9966, 1976 - Ray and Janice Anderson). [Additional Reference(s): DWR Levee Log, 2007. USACE Sacramento O&M Manual 134, June 1953, (Station 689+50)].

Concrete headwall located on waterward side.

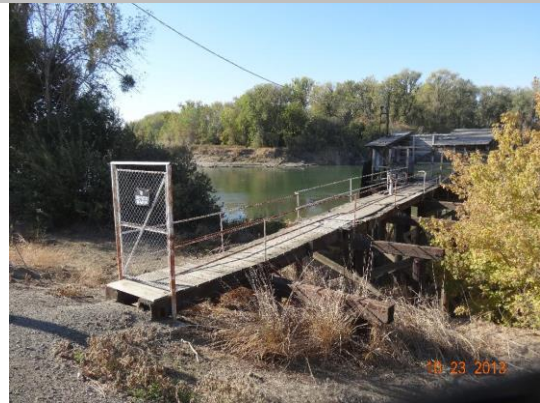
Photo 1 of 3 : UCIP_SP_2019_24108_42463.jpg

View of landward side--pump station and walkway

FS_ID:24108
DS_ID:21423
EP_NO: 9971
Repair Type: Non-Urgent
Crossing Status: Found
UCIP Comments: Will need to contact owner. Need to obtain maintenance records and clarify modifications made to crossing (size). This crossing is referenced in the USACE Periodic Inspection as item USACE_CESPK_MRD2_2012_p_0433.
FIELD_STRUCT_DESC: [Meridian Farms Water Company Pumping Plant No. 3] 2 of 3: 16-inch irrigation discharge pipe of an unknown material (not a 30-inch pipe, as mentioned in the desk study) through the levee, 20.5 feet below the crown. Gate valve on the waterside (WS) end. Pump on a pile structure in the stream. Wooden walkway to the pump. Concrete distribution box on the landside (LS). (Retention of a 30-inch steel pipe through the levee, 20.5 feet below the crown, a pump, a gate valve, and a concrete distribution box authorized under Automatic Board Order (ABO) issued as Permit No. 9971, 1974 - Georgia Chesney, Life Estate. Plans to demolish and remove the existing Meridian Diversion Pumping Facility and the existing Drexler Diversion Pumping Facility and to construct a new Meridian Diversion Pumping Facility with two retractable fish screens and a 72-inch gravity feed intake pipe under the levee authorized under Permit No. 18762, 2013 - Meridian Farms Water Company). [Additional Reference(s): DWR Levee Log, 2007].

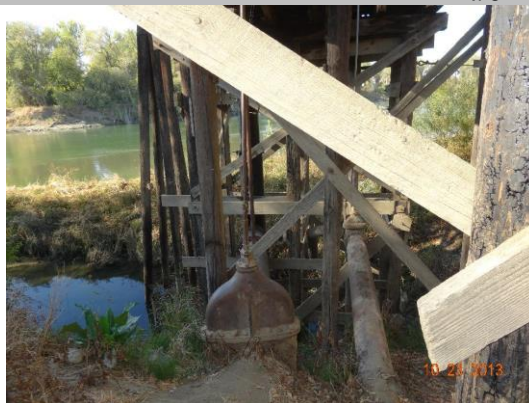
Photo 2 of 3 : UCIP_SP_2019_24108_42465.jpg

View of 16-inch pipe and 24-inch pipe with screw gate located on waterward side.

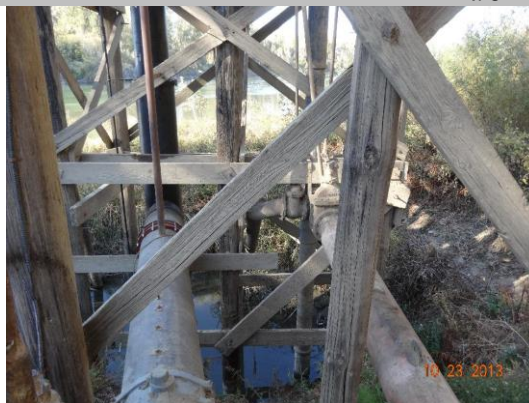
Photo 3 of 3 : UCIP_SP_2019_24108_42464.jpg

View of 16-inch pipe and 24-inch pipe located on waterward side.

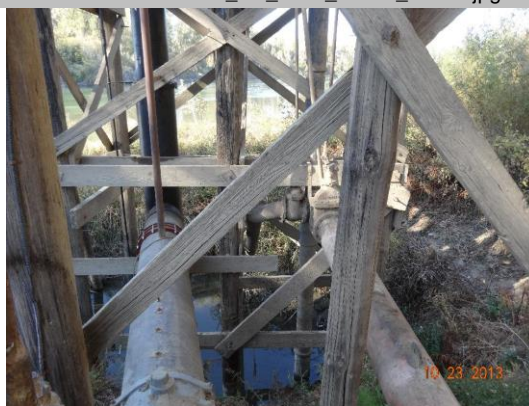
Photo 3 of 3 : UCIP_SP_2019_24107_42461.jpg

Comment Code						
Inspector Comment						
FS_ID:24107 DS_ID:21394 EP_NO: N/A Repair Type: Non-Urgent Crossing Status: Found UCIP Comments: This pump station is to be demolished. This crossing will need to be updated once the work has been completed. This crossing is referenced in the USACE Periodic Inspection as item USACE_CESPK_MRD2_2012_p_0433. FIELD_STRUCT_DESC: [Meridian Farms Water Company Pumping Plant No. 3] 3 of 3: 24-inch irrigation discharge pipe of an unknown material through the levee, 20.5 feet below the crown. Gate valve on the waterside (WS) end. Pump on a pile structure in the stream. Wooden walkway to the pump. Concrete distribution box on the landside (LS). (Plans to demolish and remove the existing Meridian Diversion Pumping Facility and the existing Drexler Diversion Pumping Facility and to construct a new Meridian Diversion Pumping Facility with two retractable fish screens and a 72-inch gravity feed intake pipe under the levee authorized under Permit No. 18762, 2013 - Meridian Farms Water Company). [Additional Reference(s): DWR Levee Log, 2007]. FS Date: 10/23/2013

View of pipes located on waterward side.

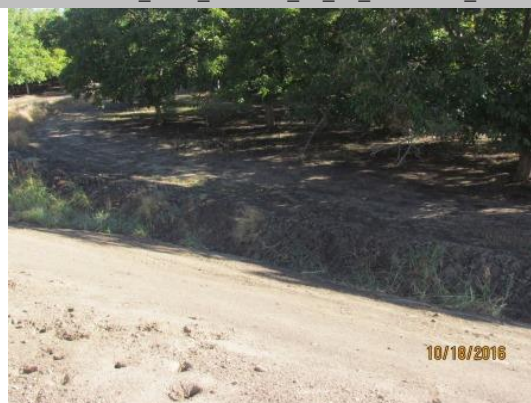
Photo 1 of 1 : SP_2019_RD0070_30_62_20190326_00010.jpg

LM Start	9.57	Rating **	M	Issue No.	62
LM End	9.70	Issue Type +	En	Location *	LS
Category	Earthen Levee			GPS Latitude/Longitude	
				Start	End
Item	Encroachments			39.103192 °	39.101213 °
				-121.899606 °	-121.899380 °
DWR ID	DWR_RD0070_02_f_2016_62				
Comment Code					
DT : Ditch					
Inspector Comment

View of a ditch along the landside toe.

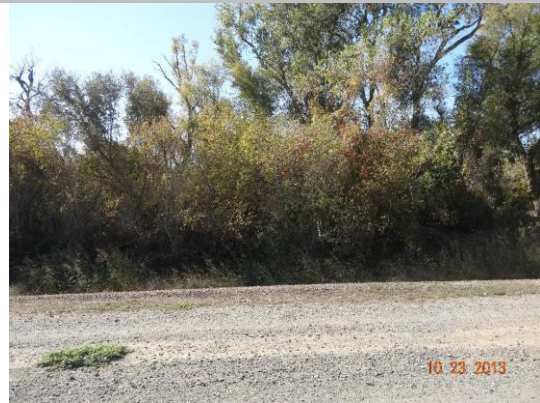
Photo 1 of 3 : UCIP_SP_2019_23967_42129.jpg

Comment Code					
Inspector Comment					
FS_ID:23967 DS_ID:21396 EP_NO: N/A Repair Type: Non-Urgent Crossing Status: Indicator Found UCIP Comments: No evidence of pipe is visible on waterward side. Need to coordinate with owner to determine status of crossing. If crossing is no longer in use owner will need to contact the CVFPB to comply with Title 23. This crossing is referenced in the USACE Periodic Inspection as item USACE_CESPK_MRD2_2012_p_0477. FIELD_STRUCT_DESC: *ABANDONED* 12-inch pipe of an unknown material or purpose through the levee, 3.1 feet below the crown. Siphon breaker in a corrugated metal pipe (CMP) riser on the landside (LS) shoulder. Concrete plug on the LS end. Wooden distribution box on the LS at the discharge end. (Cat. IV-A). [Additional Reference(s): DWR Levee Log, 2007. USACE Sacramento O&M Manual 134, June 1953, (Station 813+00)]. FS Date: 10/23/2013

View of waterward side.

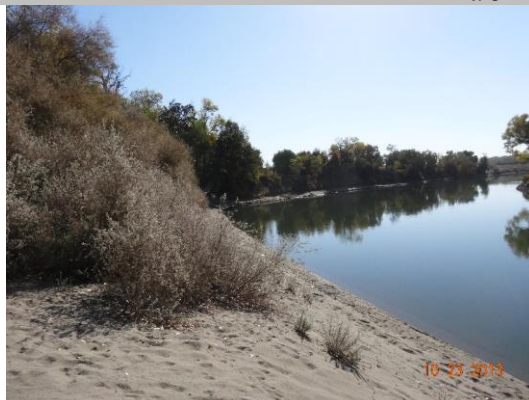
Photo 2 of 3 : UCIP_SP_2019_23967_42132.jpg

Item	DWR UCIP Field Study			39.096935 °	39.096935 °	
				-121.893870 °	-121.893870 °	
DWR ID	21396					
Comment Code						
Inspector Comment						
FS_ID:23967 DS_ID:21396 EP_NO: N/A Repair Type: Non-Urgent Crossing Status: Indicator Found UCIP Comments: No evidence of pipe is visible on waterward side. Need to coordinate with owner to determine status of crossing. If crossing is no longer in use owner will need to contact the CVFPB to comply with Title 23. This crossing is referenced in the USACE Periodic Inspection as item USACE_CESPK_MRD2_2012_p_0477. FIELD_STRUCT_DESC: *ABANDONED* 12-inch pipe of an unknown material or purpose through the levee, 3.1 feet below the crown. Siphon breaker in a corrugated metal pipe (CMP) riser on the landside (LS) shoulder. Concrete plug on the LS end. Wooden distribution box on the LS at the discharge end. (Cat. IV-A). [Additional Reference(s): DWR Levee Log, 2007. USACE Sacramento O&M Manual 134, June 1953, (Station 813+00)]. FS Date: 10/23/2013

No pipe exists levee on waterward side only CMP riser present on landward side.

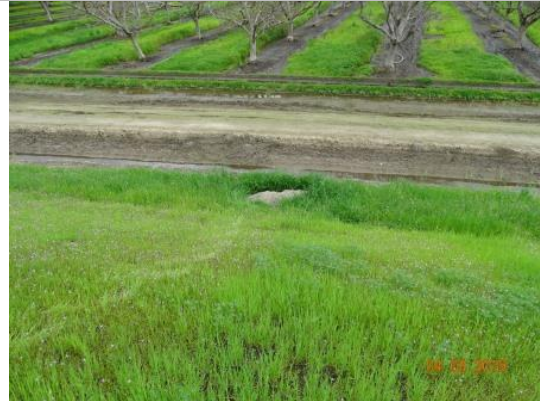
Photo 1 of 1 : SP_2019_RD0070_30_79_20190408_00125.jpg

LM Start	10.30	Rating **	U	Issue No.	79
LM End	10.30	Issue Type +	Ma	Location *	LS
Category	Earthen Levee			GPS Latitude/Longitude	
				Start	End
Item	Animal Control			39.095102 °	39.095102 °
				-121.892786 °	-121.892786 °
DWR ID	DWR_RD0070_02_s_2019_79				
Comment Code					
A3 : No rodents visible, but rodent burrows visible; need to backfill and compact or grout burrows.					
Inspector Comment

View of the rodent burrow at the landside toe. Spring 2019.

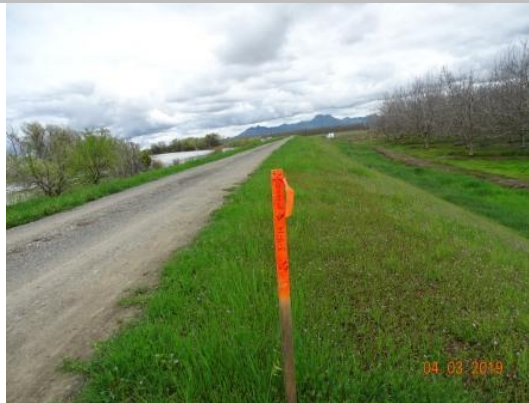
Photo 1 of 2 : SP_2019_RD0070_30_77_20190408_00120.jpg

LM Start	10.76	Rating **	A	Issue No.	77
LM End	10.76	Issue Type +	Ob	Location *	LS
Category	Earthen Levee			GPS Latitude/Longitude	
				Start	End
Item	Seepage / Sandboils			39.088646 °	39.088646 °
				-121.893987 °	-121.893987 °
DWR ID	DWR_RD0070_02_s_2019_77				
Comment Code					
Inspector Comment					
RD placed a stake to mark the location of a boil. RD mentioned that the boil is within the ditch. Boil should be monitored during high water.

View of the stake to mark the boil location.

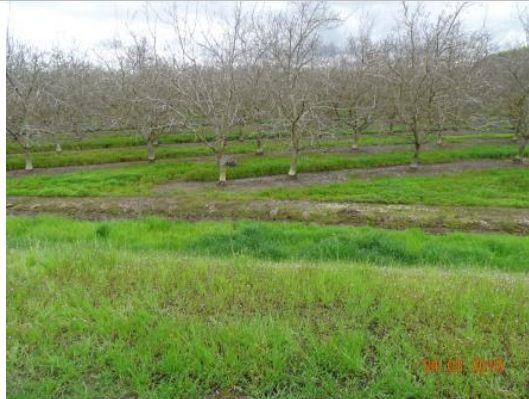
Photo 2 of 2 : SP_2019_RD0070_30_77_20190408_00121.jpg

View of the ditch on the landside and outside of the levee easement.

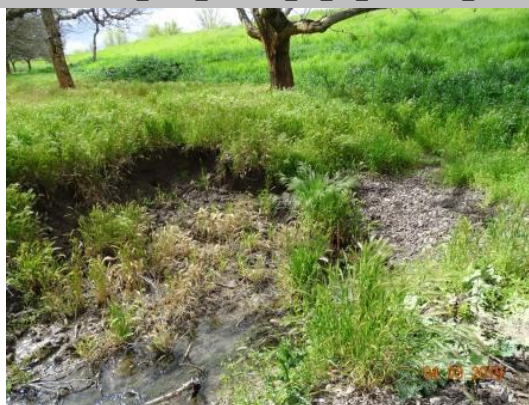
Photo 1 of 1 : SP_2019_RD0070_30_65_20190408_00123.jpg

LM Start	12.21	Rating **	A	Issue No.	65
LM End	12.21	Issue Type +	Ob	Location *	LS
Category	Earthen Levee		GPS Latitude/Longitude		
			Start	End	
Item	Seepage / Sandboils		39.074106 °	39.074106 °	
			-121.889696 °	-121.889696 °	
DWR ID	DWR_RD0070_02_s_2019_65				
Comment Code					
Inspector Comment					
RD placed a stake to mark the location of a boil. RD mentioned that the boil is within the ditch. Continue monitoring the boil during high water.

View of the ditch on the landside within the levee easement.

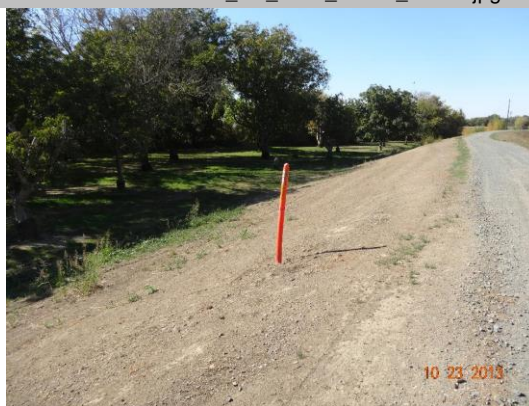
Photo 1 of 3 : UCIP_SP_2019_23984_42172.jpg

Comment Code						
Inspector Comment						
FS_ID:23984 DS_ID:21403 EP_NO: 3800 Repair Type: Non-Urgent Crossing Status: Indicator Found UCIP Comments: Need to contact owner to determine if crossing is still active and to determine last inspection date. Will need copy of letter showing crossings passed inspection. This crossing is referenced in the USACE Periodic Inspection as item USACE_CESPK_MRD2_2012_p_0568. FIELD_STRUCT_DESC: 20-inch coated steel natural gas pipeline through the levee, 3 feet below the crown. Concrete cutoff wall around the pipe at the center of the levee. Marker sign on the waterside (WS) shoulder. Natural gas equipment pad at the landside (LS) toe. (Plans to construct and maintain a 20-inch gas line across the Sacramento River authorized under Permit No. 3800, 1961 - Pacific Gas and Electric Company [PG&E]). [Additional Reference(s): DWR Levee Log, 2007]. FS Date: 10/23/2013

Marker located on waterward side.

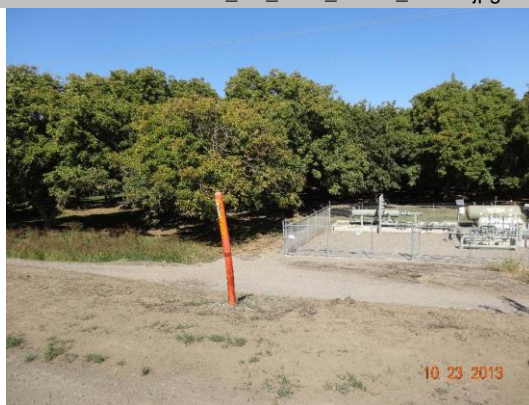
Photo 2 of 3 : UCIP_SP_2019_23984_42171.jpg

Marker on landward side.

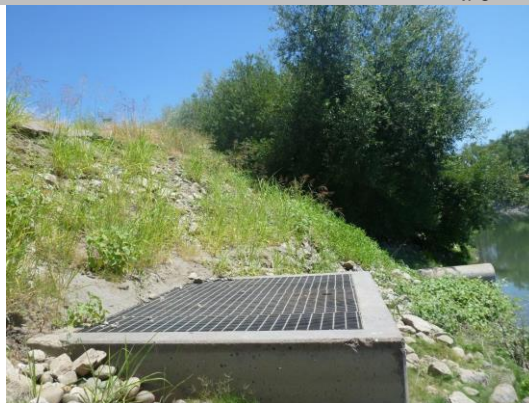
LM Start	13.83	Rating **	A/W	Issue No.	75
LM End	13.83	Issue Type +	Ma	Location *	
Category	Supplemental			GPS Latitude/Longitude	
				Start	End
Item	2017 Storm Damage			39.068190 °	39.068190 °
				-121.862700 °	-121.862700 °
DWR ID	DWR_RD0070_02_f_2017_75				
Comment Code					
Inspector Comment					
Levee Evaluation Comments					
Description:					
Site ID No:152					
Site Designation:RD 70-01					
Repair Type: Erosion					
Rating:Area of Concern					
Field Date:7/17/2017					
Notes: bank slope erosion around a drainage pipe/box

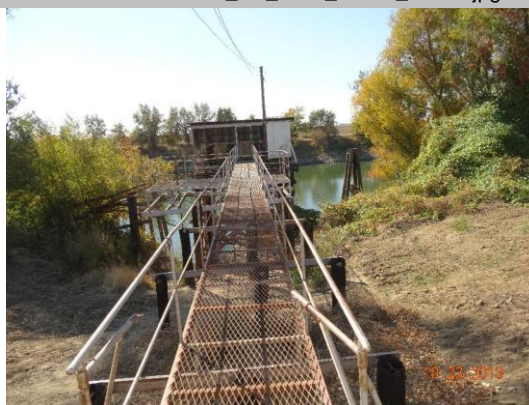
Photo 1 of 3 : UCIP_SP_2019_24229_42848.jpg

Comment Code					
Inspector Comment					
FS_ID:24229 DS_ID:21421 EP_NO: 9990 Repair Type: Non-Urgent Crossing Status: Found UCIP Comments: Need to determine if crossings are still being used. This crossing is referenced in the USACE Periodic Inspection as item USACE_CESPK_MRD2_2012_p_0685. FIELD_STRUCT_DESC: 1 of 2: 24-inch steel irrigation discharge pipe sleeved through a 30-inch coated steel pipe through the levee, 24 feet below the crown. Gate valve on the waterside (WS) end. Concrete headwall with a flap gate on the landside (LS). Pump on a pile structure in the stream. Wooden walkway to the pump. (Retention of two 24-inch steel pipes through the levee, 24 feet below the crown, two pumps, and two gate valves authorized under Automatic Board Order (ABO) issued as Permit No. 9990, 1974 - Newhall Land and Farming Company). [Additional Reference(s): DWR Levee Log, 2007. USACE Sacramento O&M Manual 134, June 1953, (Station 1086+55)]. FS Date: 10/23/2013

Walkway and pump house on waterward side.

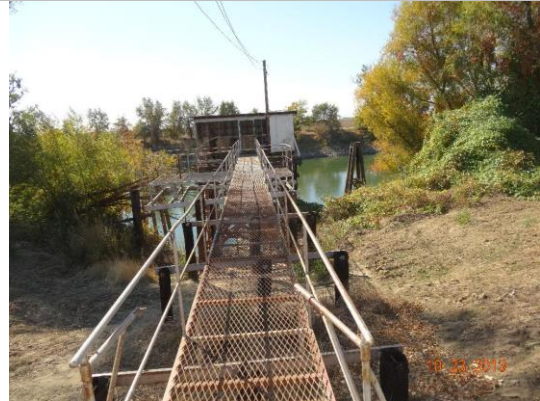
Photo 1 of 3 : UCIP_SP_2019_24230_42854.jpg

FS_ID:24230
DS_ID:21409
EP_NO: 9990
Repair Type: Non-Urgent
Crossing Status: Found
UCIP Comments: Need to determine if crossing is still being used. This crossing is referenced in the USACE Periodic Inspection as item USACE_CESPK_MRD2_2012_p_0685.
FIELD_STRUCT_DESC: 2 of 2: 24-inch steel irrigation discharge pipe sleeved through a 30-inch coated steel pipe through the levee, 24 feet below the crown. Gate valve on the waterside (WS) end. Concrete headwall with a flap gate on the landside (LS). Pump on a pile structure in the stream. Wooden walkway to the pump. (Retention of two 24-inch steel pipes through the levee, 24 feet below the crown, two pumps, and two gate valves authorized under Automatic Board Order (ABO) issued as Permit No. 9990, 1974 - Newhall Land and Farming Company).
[Additional Reference(s): DWR Levee Log, 2007. USACE Sacramento O&M Manual 134, June 1953, (Station 1086+55)].
FS Date: 10/23/2013

LM Start	15.34	Rating **	M	Issue No.	140 (cont)
LM End	15.34	Issue Type +	En	Location *

Walkway and Pump house located on waterward side.

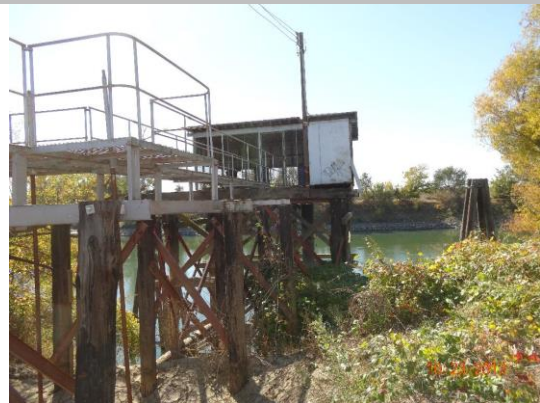
Photo 2 of 3 : UCIP_SP_2019_24230_42855.jpg

Pump located on waterward side.

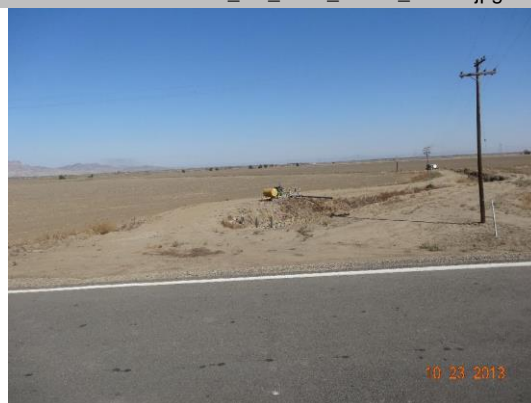
Photo 3 of 3 : UCIP_SP_2019_24230_42858.jpg

Item	DWR UCIP Field Study			39.065294 °	39.065294 °	
				-121.839215 °	-121.839215 °	
DWR ID	21409					
Comment Code						
Inspector Comment						
FS_ID:24230 DS_ID:21409 EP_NO: 9990 Repair Type: Non-Urgent Crossing Status: Found UCIP Comments: Need to determine if crossing is still being used. This crossing is referenced in the USACE Periodic Inspection as item USACE_CESPK_MRD2_2012_p_0685. FIELD_STRUCT_DESC: 2 of 2: 24-inch steel irrigation discharge pipe sleeved through a 30-inch coated steel pipe through the levee, 24 feet below the crown. Gate valve on the waterside (WS) end. Concrete headwall with a flap gate on the landside (LS). Pump on a pile structure in the stream. Wooden walkway to the pump. (Retention of two 24-inch steel pipes through the levee, 24 feet below the crown, two pumps, and two gate valves authorized under Automatic Board Order (ABO) issued as Permit No. 9990, 1974 - Newhall Land and Farming Company). [Additional Reference(s): DWR Levee Log, 2007. USACE Sacramento O&M Manual 134, June 1953, (Station 1086+55)]. FS Date: 10/23/2013

Overview of landward side.

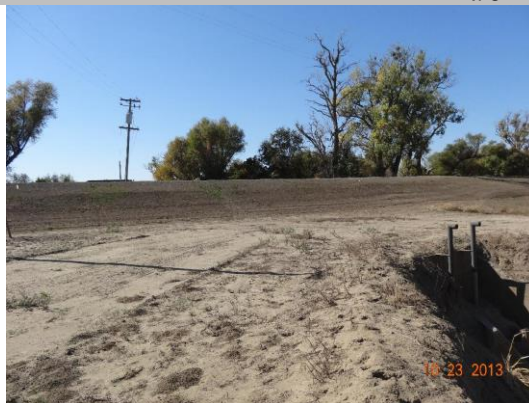
Photo 3 of 3 : UCIP_SP_2019_24231_42860.jpg

Item	DWR UCIP Field Study			39.065285 °	39.065285 °	
				-121.839202 °	-121.839202 °	
DWR ID	21420					
Comment Code						
Inspector Comment						
FS_ID:24231 DS_ID:21420 EP_NO: N/A Repair Type: Non-Urgent Crossing Status: Found UCIP Comments: No daylight visible on landward side. Pipe was visible on waterward side. Need to contact owner to determine status of crossing. This crossing is referenced in the USACE Periodic Inspection as item USACE_CESPK_MRD2_2012_p_0685. FIELD_STRUCT_DESC: 16-inch steel irrigation discharge pipe through the levee, approximately 15 feet below the crown. Gate valves on the waterside (WS) end. Pumps on the WS. [Additional Reference(s): USACE Sacramento O&M Manual 134, June 1953, (Station 1086+55)]. FS Date: 10/23/2013

View of landward side photo taken from concrete headwall.
